OCCUPATIONAL ACCIDENT

Very serious marine casualty: Three fatalities under the bow ramp on a RO-RO passenger ferry

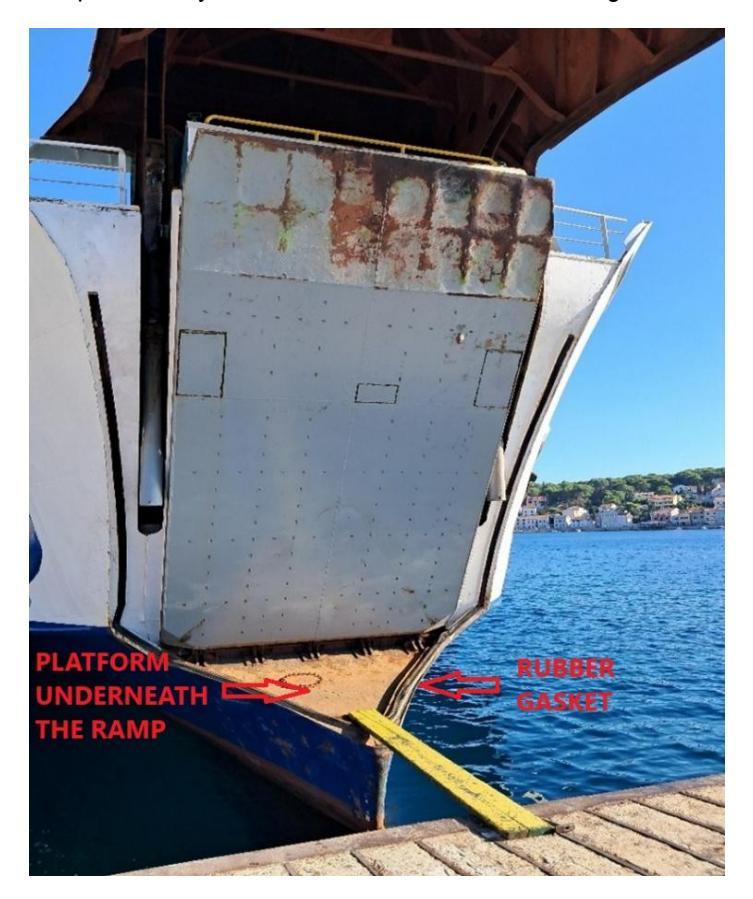
On 11 August 2024, upon arrival at the port of Mali Lošinj, Croatia, the crew members of the RO-RO passenger ferry "Lastovo", built in 1969, proceeded to inspect the condition of the bow visor rubber gasket. This required the bow ramp to be fully raised in order to access the triangular bulbous bow platform.

Safe operating and securing the ramp has to be performed on three different locations on board, in a specific sequence. On the day of the accident, the crew did not secure the ramp as they had routinely done before departure. This was primarily because the task was not part of their usual routine but was intended only as a quick inspection of the gasket's condition.

Some types of bow ramp hydraulic systems are designed in such a way that they cannot self-hold if the hydraulic system is turned off and the ramp is not mechanically secured. The company should identify the capabilities and limitations of such technical designs and make this information available to the crew, ensuring appropriate familiarization with specific systems.
