Maritime &  
Coastguard  
Agency

# **Safety Bulletin 4: Automatic water mist sprinkler systems**

Published 18 December 2015

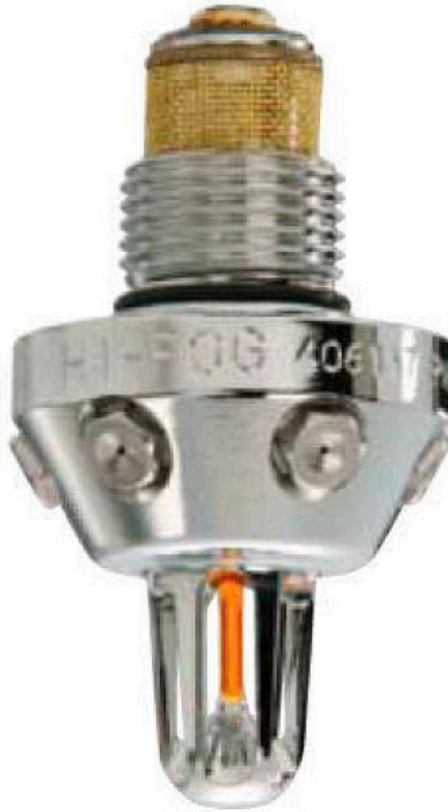
In this instance a significant proportion of the Marioff Corporation Hi-Fog 1000-Series automatic sprinkler nozzles had failed to activate at the pilot pressure (minimum operating pressure); other water mist systems may also be susceptible to the root causes described below:

- Poor water quality
- Increased corrosion of sprinkler body and quicker ageing of O-rings
- Water leakage past O-rings results in deposits
- Piston and other dynamic components have an increased resistance
- Automatic nozzle fails to activate at the normal pilot water pressure

Figure: Marioff Hi-Fog 1000-Series Automatic Sprinkler Nozzle

It is advised that owners/operators of automatic water mist sprinkler systems consult with their original equipment manufacturer to ensure the operation of these sprinkler systems and to confirm a suitable maintenance and testing regime exists.
